Fact or Myth: Is America's Stonehenge Restored Beyond Study?

Mary E. Gage

© November 2021. All Rights Reserved.

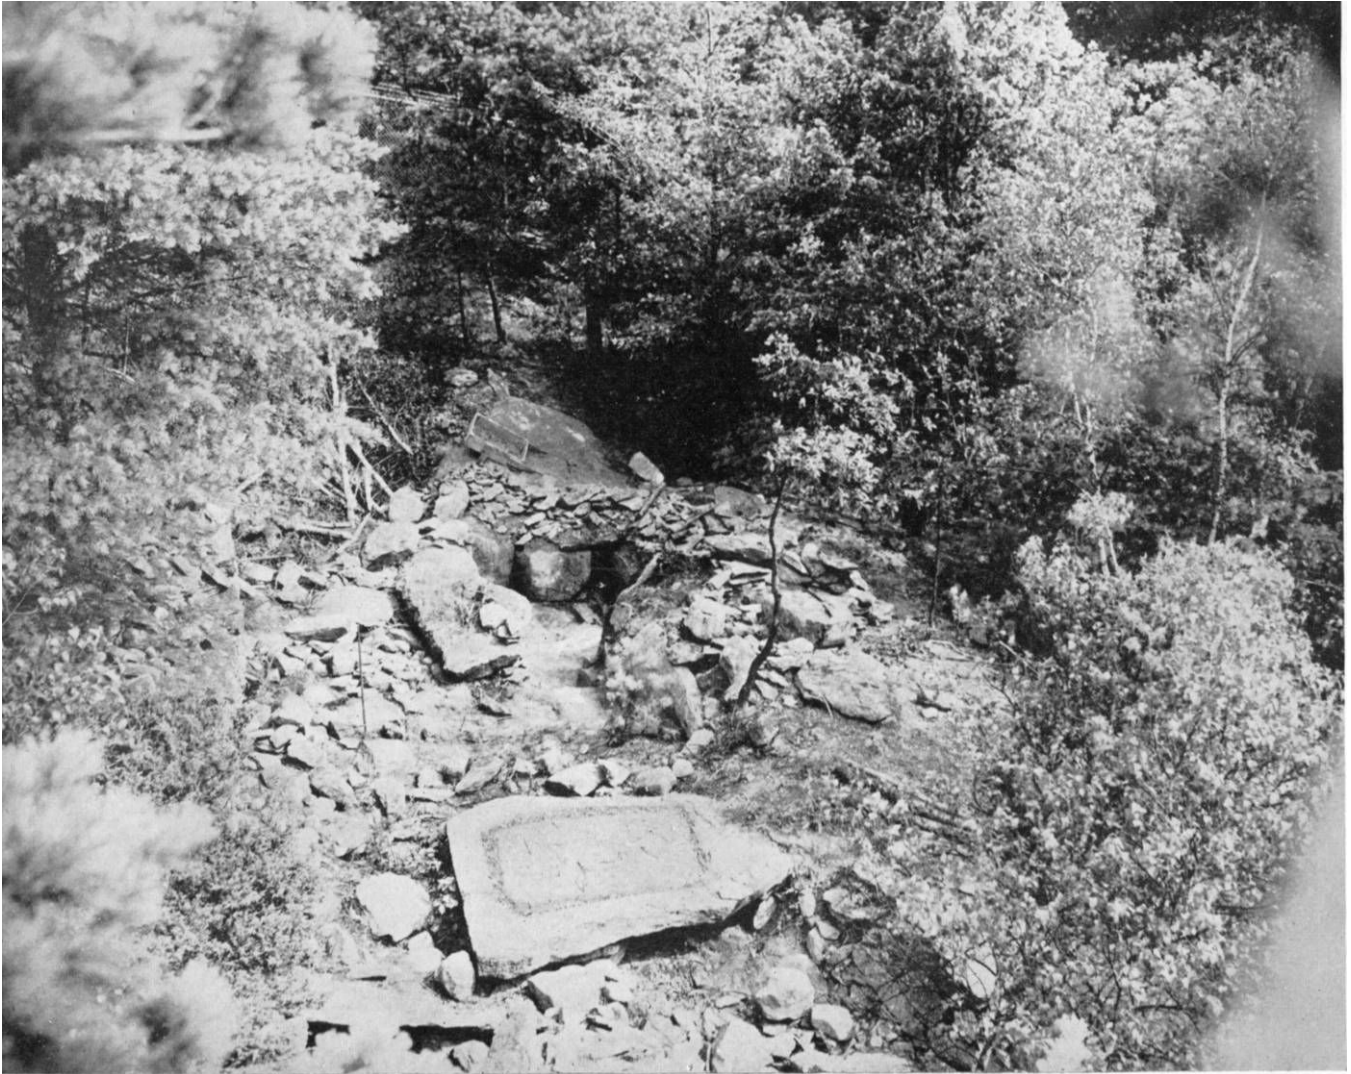
A before restoration photograph of the front east edge of the Ramp and Grooved Stone area show a lot of loose stone on the bedrock. (fig.5) Another pre-restoration photo seems to show the east wall of the Ramp intact. (fig.6) The statement the “Ramp itself was partially filled” appears accurate as loose stone in front of it was replaced on top. (fig.7) As for the restoration Goodwin was specific about the repair to the east wall whereas Vescelius is vague. It does not seem plausible the east wall totally collapsed after it was “straightened up” and made “even more solid than before”. Furthermore, even if the wall was “completely rebuilt” its appearance, length and height would not have been altered due to the fact the

Figure 5 – Pre-restoration photo c.1938 of the ramp (left side-covered with vegetation), grooved stone (center) and Oracle Chamber (right of Grooved Stone). An archeological excavation is in progress near the top center of the photo. (Photo by Malcolm Pearson from Goodwin 1946, 91)

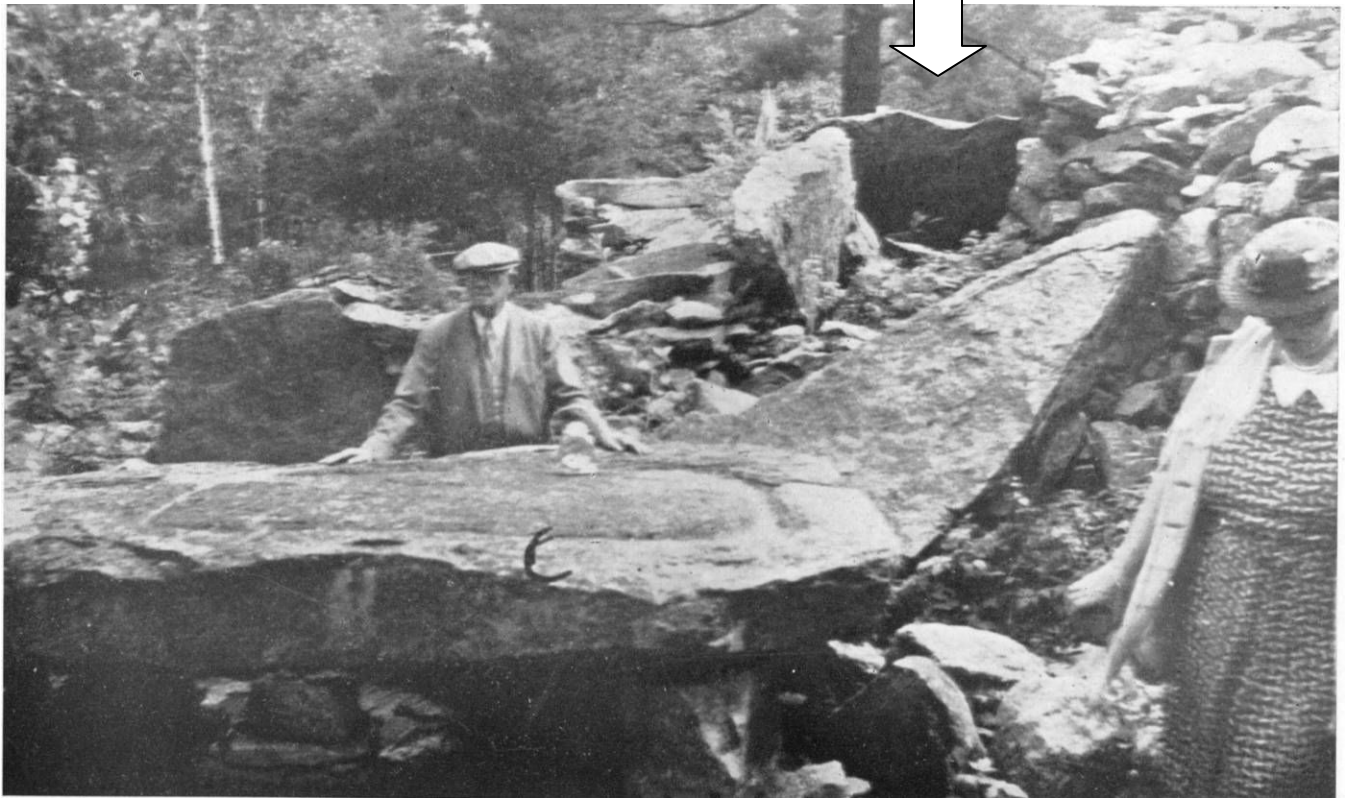
Figure 6 – Pre-restoration photo circa 1937 or 1938 showing William Goodwin behind the Grooved Stone. The upper structure of the Sundeck Chamber is visible in the photo (indicated by arrow). Also note that the east wall of the ramp is visible on the right side of photo. It is bulging outward but intact. (Photo by Malcolm Pearson from Goodwin 1946, 83)

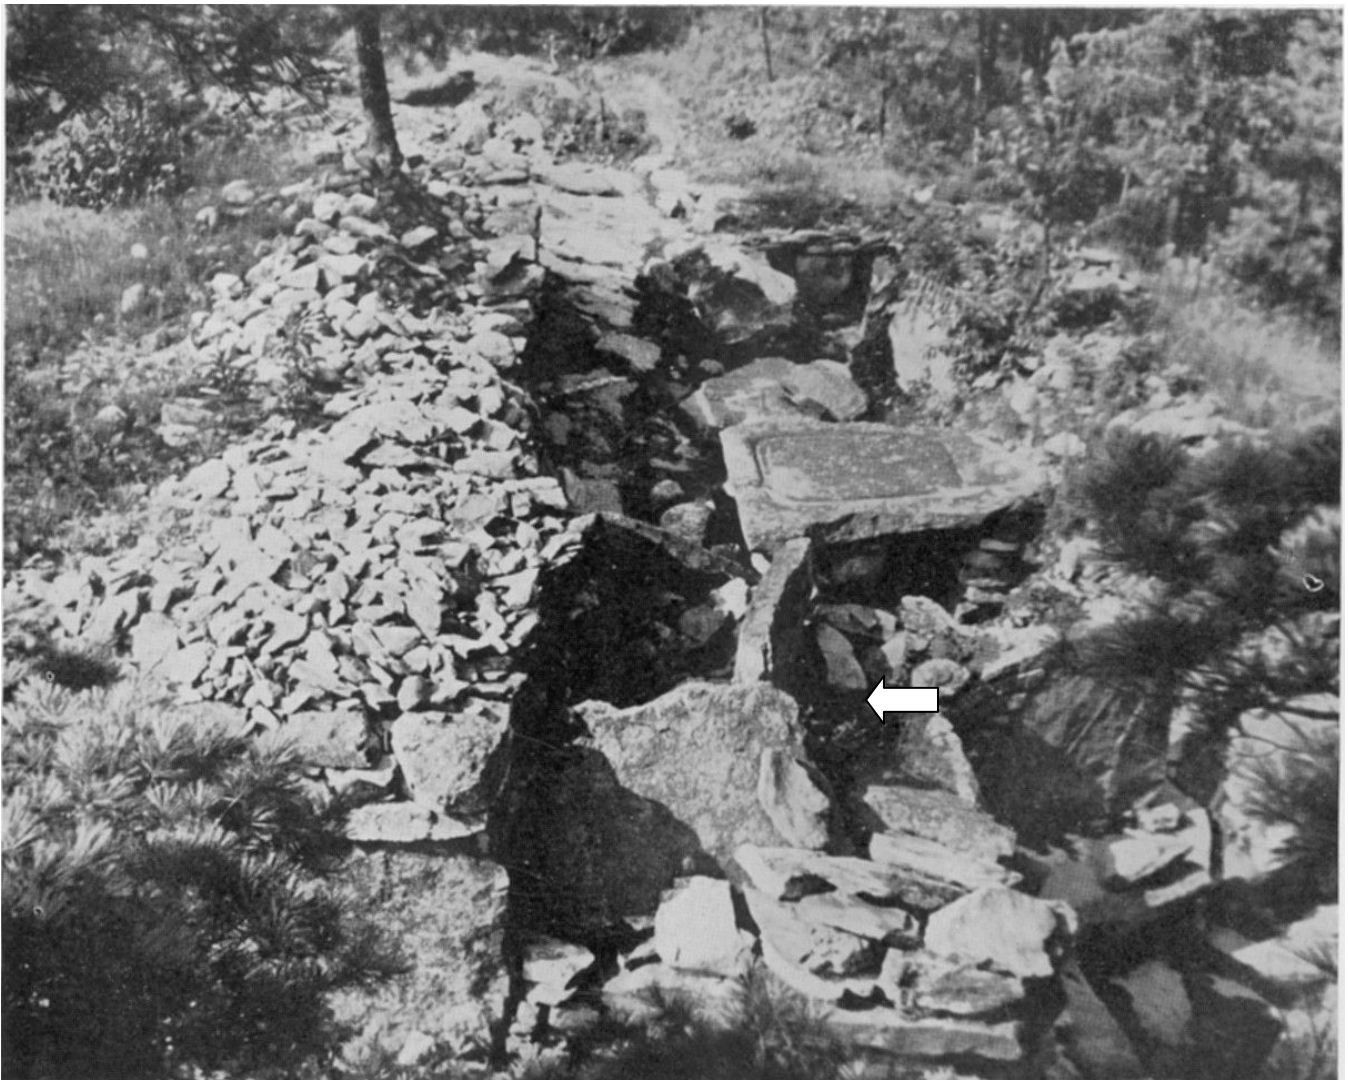
Figure 7 – Photo during restoration. Stones on the bedrock around the Grooved Stone have been placed on top of the Ramp. The upper structure of the Sundeck Chamber is shown (indicated by arrow). (Photo by Malcolm Pearson from Goodwin 1946, 92)

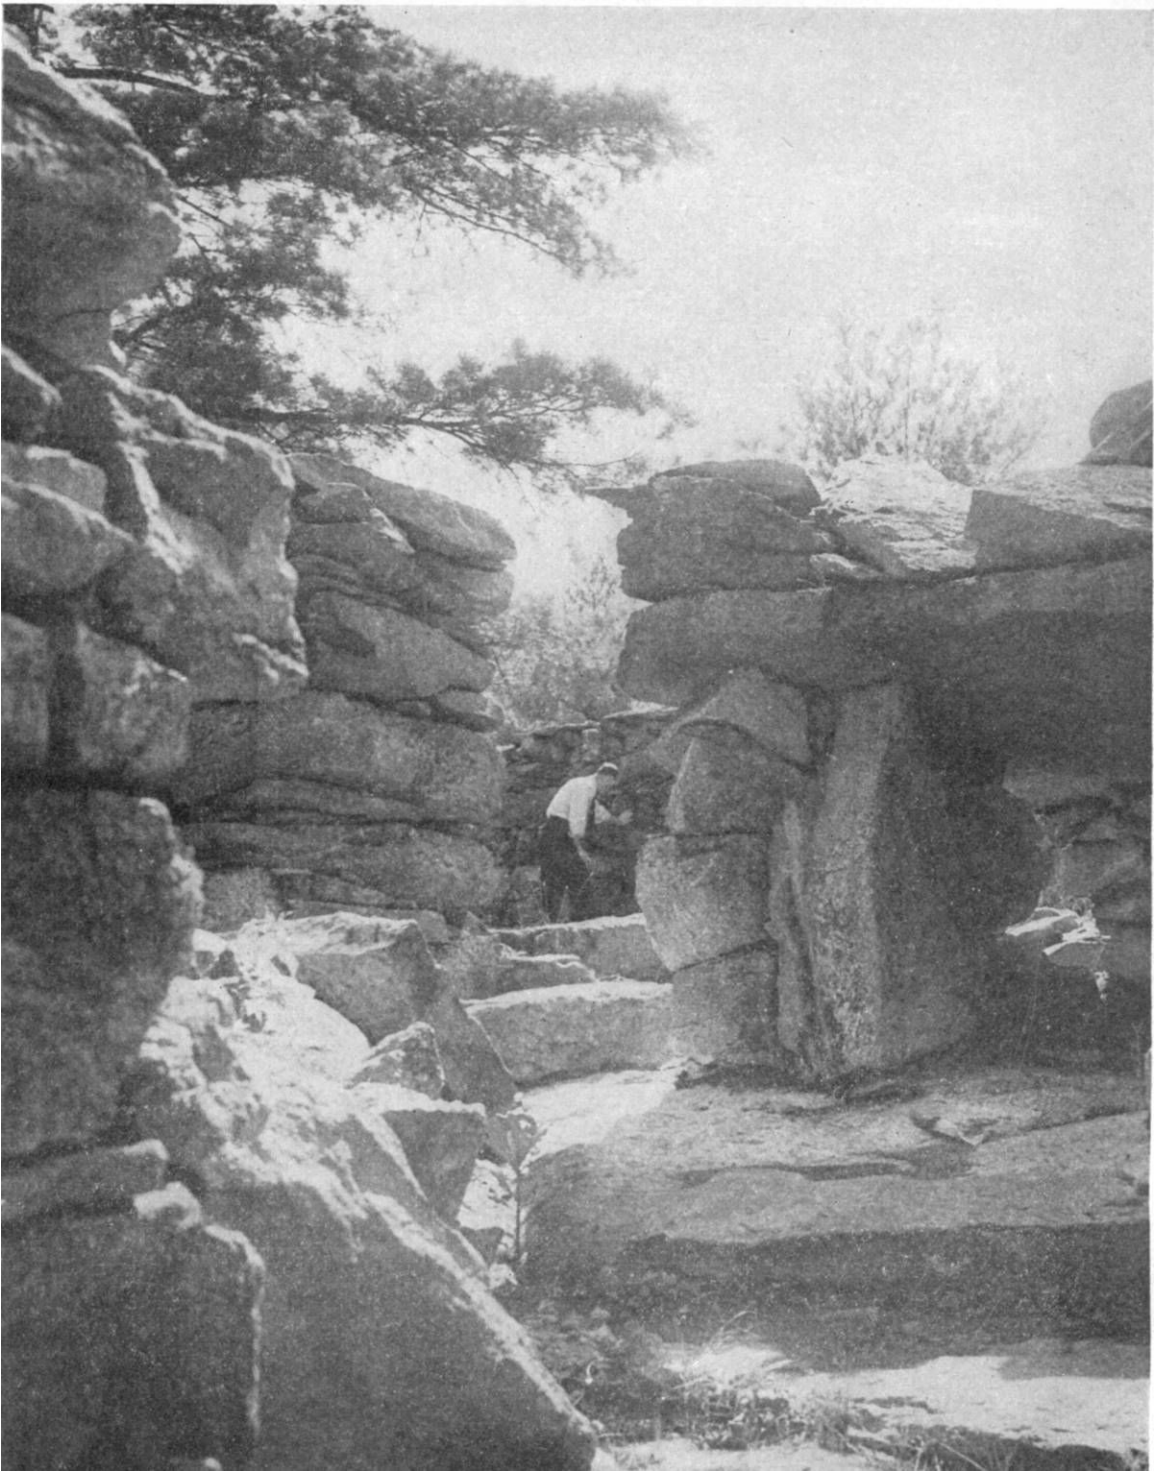
Chamber: A photograph of the outer thin side wall of the chamber appears in the frontispiece of Goodwin’s book. (fig.8) The wall is one stone wide with a tall triangular slab just inside that reaches up to the underside of the chamber’s roof slab. A small opening (not visible) in the rear of the side wall is evidenced by sunlight coming into the interior. The thin wall and standing stone support the five and half foot by five foot by one foot thick roof slab. In this photograph is the original side wall and its features. The thin side wall has been completely rebuilt, see current photograph. (fig.9) The rebuilding of the side wall maintained the small opening in the wall’s southwest corner. However, the standing stone has been removed. Its location is unknown. Using the old photograph in conjunction with the current state the chamber is in made it possible to study.

Figure 8 – View of the lower structure of the Sundeck Chamber circa early 1940s. Photo taken from alcove of the Oracle Chamber. Photo shows the one stone wide support wall and triangular stone. The triangular stone is now missing and the wall rebuilt. Photo allows for evaluation of the structure prior to later repairs. (Photo by Malcolm Pearson from Goodwin 1946, frontis)

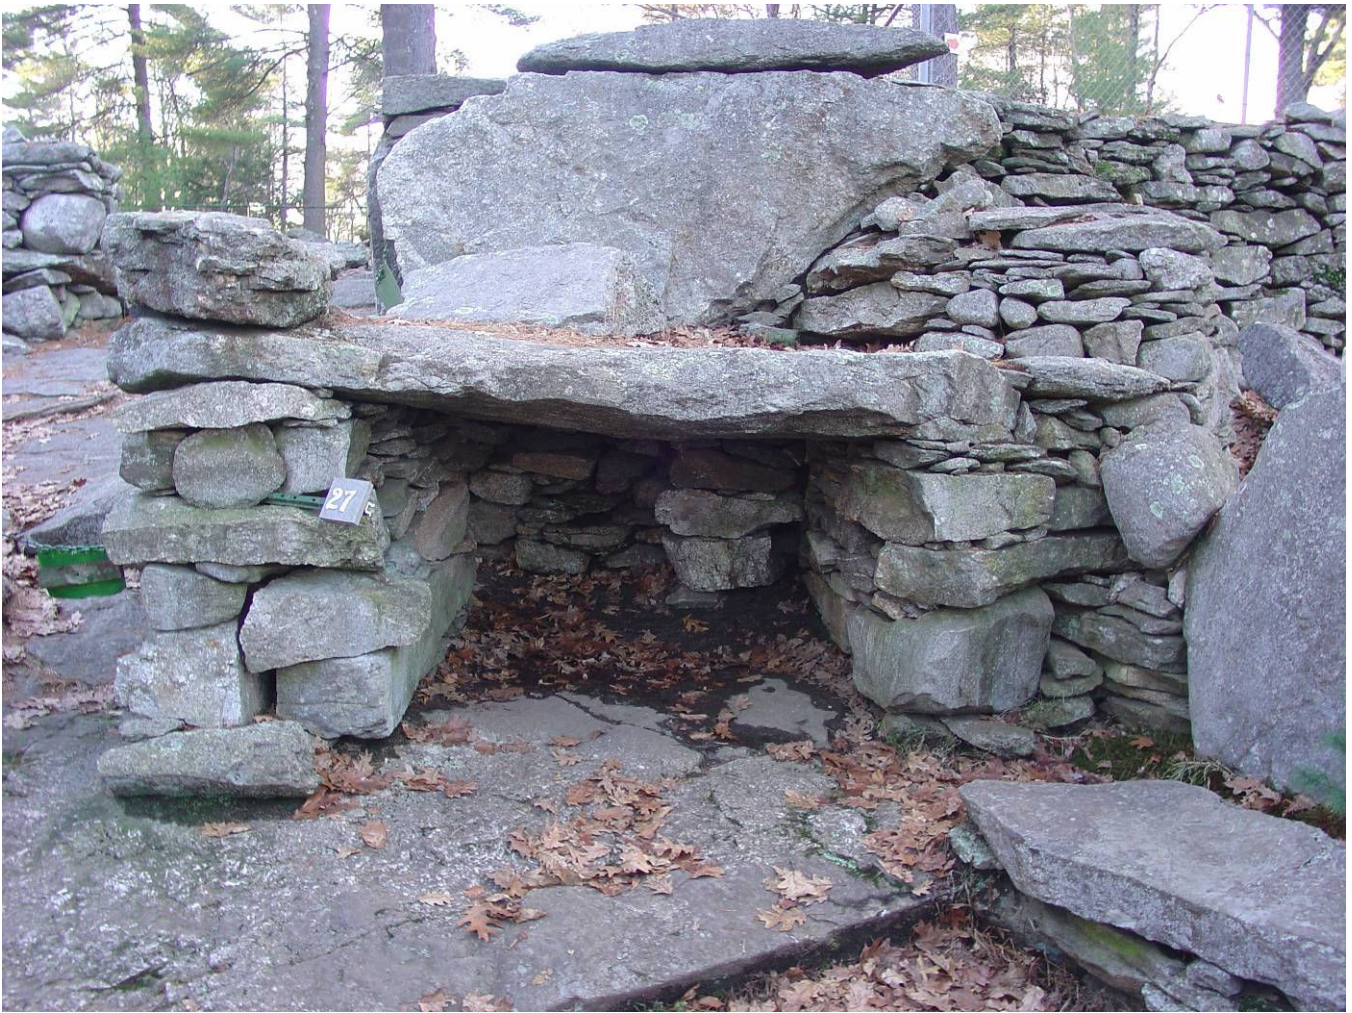
Figure 9 – Sundeck Chamber as it looks today. The left hand support wall has been altered and completely rebuilt. The stones on the upper structure have been re-arranged and does not reflect its original configuration. (Photograph by James Gage)

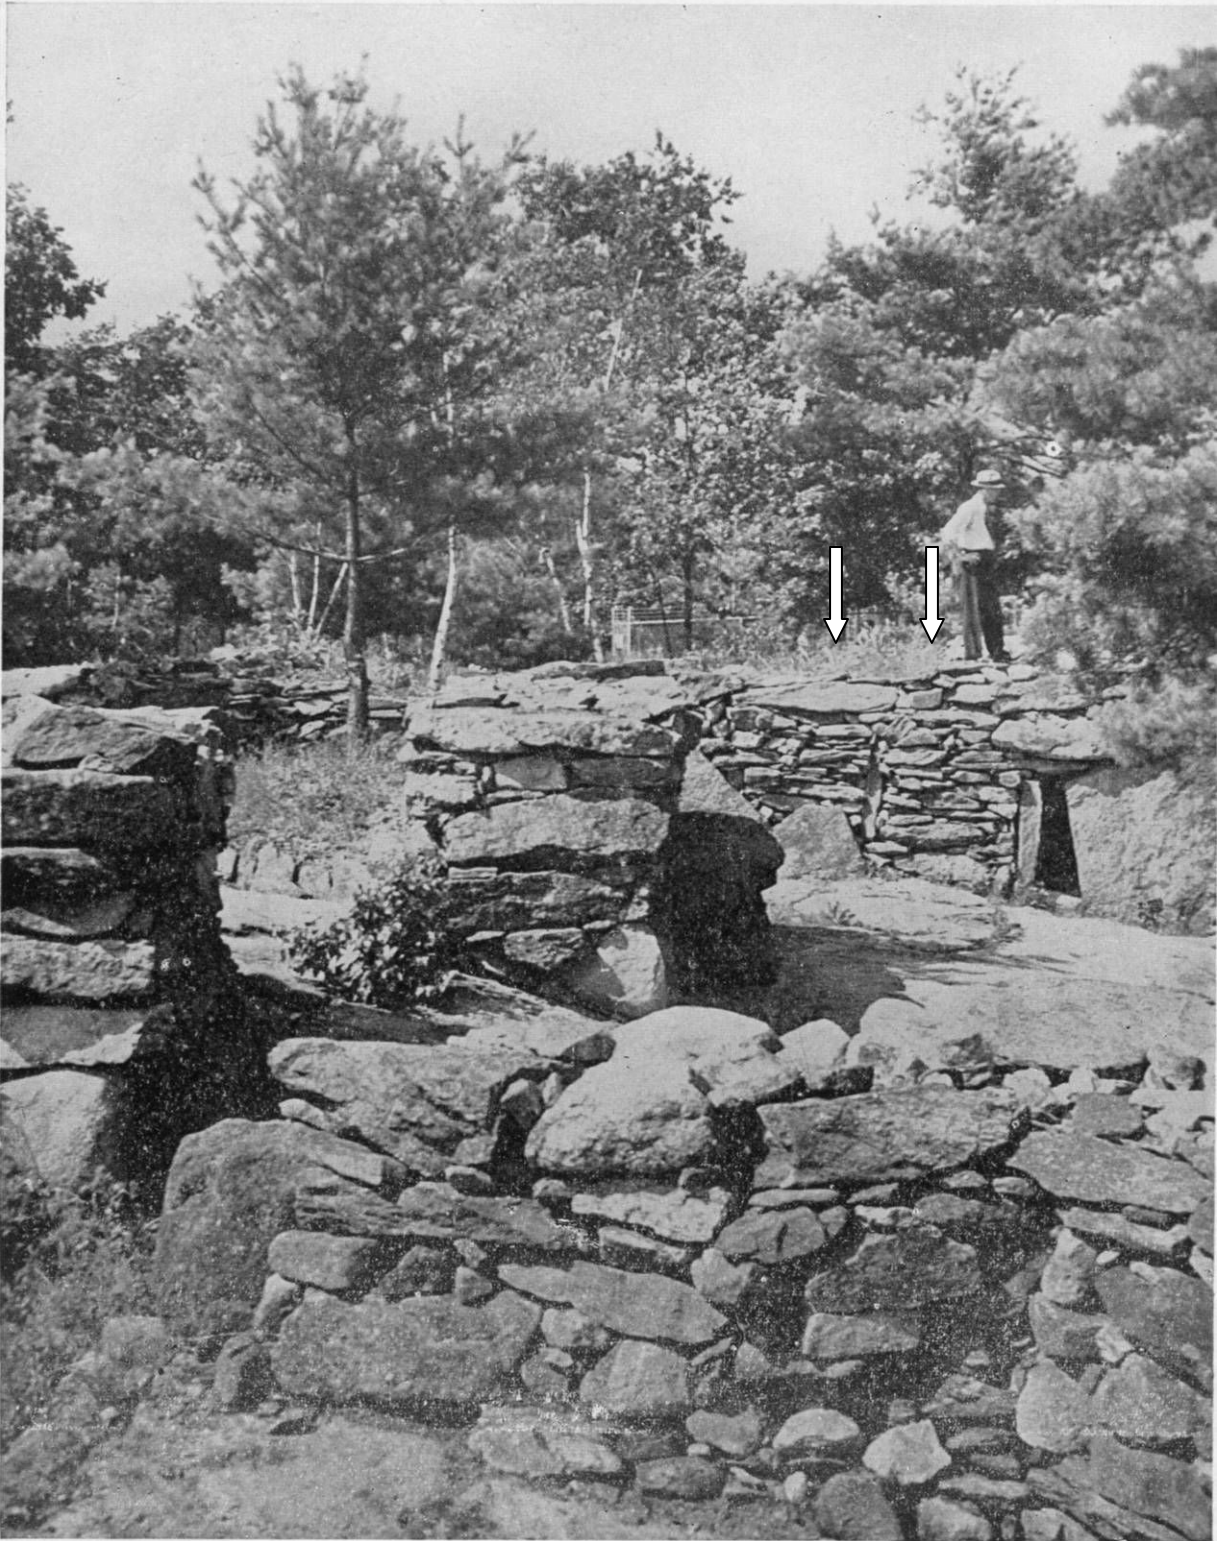
During Goodwin's era restoration, only the middle section of the East-West Chamber was filled in with stone. (fig.12) That changed later. A comparison of the stone slab in the east end was made with an undated photograph in a 1958 publication *The North Salem Mystery*.¹³ (figs.14, 15 & 16) The slab in place in 1958 appears to have a vertical ridge on its face casting a shadow the same ridge as on the stone currently in place. That indicates the original stone slab Goodwin's crew kept in the chamber had been replaced. Attached to the east end of the East-West Chamber is the Sundeck Chamber. Goodwin found three large stone slabs on top of the Sundeck Chamber. Today, there are two on top and in a totally different configuration than Goodwin had found them. There is a high probability the current stone slab in the east end of the East-West Chamber came from the top of the Sundeck.

Figure 12 – Post-restoration photo of East-West Chamber circa early 1940s. Middle section rebuilt by Goodwin’s crew. (Photo by Malcolm Pearson from Goodwin 1946, 80)

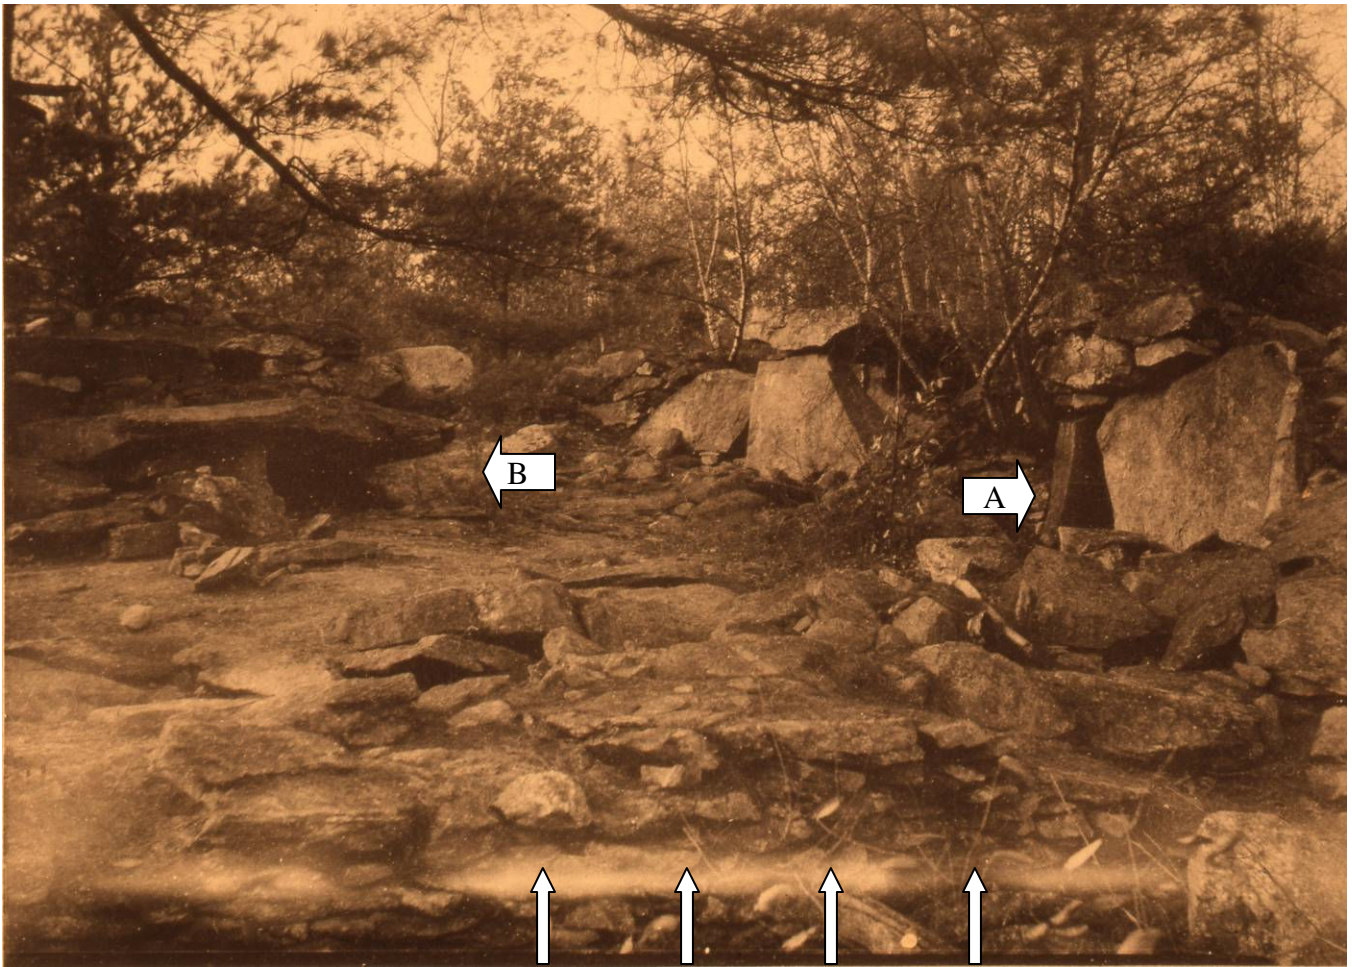
A before restoration photograph taken from the east side of the Tall Wall structure shows its foundation. (Fig.13) Vescelius stated, "The foundations of most, if not all, of the present structures did, indeed, exist prior to the inception of Goodwin's work." The before restoration photograph concurs with Vescelius' statement. In the photograph the dismantled wall stones are seen next to the wall's foundation. Although the wall was "totally reconstructed" its length and width were known by its "foundation". The one unknown was its height which was achieved by using only the stone within three feet of it in the restoration. The stone beside the wall dictated the type and size of stone. Across the plaza from the Tall Wall is the Mensal Stone Chamber another structure with a tall wall. Its lower two thirds was intact when Goodwin acquired the site. That chamber's tall wall had the same type and size of stone as was next to the Tall Wall. Goodwin's crew therefore had a partially intact wall as an example of the construction style used by the original builders. His crew were astute observers. They noticed two large slabs had quarry marks left from the slabs being split in half. (fig.19) Of the two slabs one had "feathermarked" half holes. Unbeknown to anyone assisting Goodwin these were trapezoid holes used with the flat-wedge method that date from 1800 to 1870s. The other slab had half-round holes used with the plug n' feather method that dates from the early 1820s to 2021.¹⁵ The workers correctly placed the slabs so the half-holes were at the top edge and facing outward. In addition, they noticed an abraded slot on the end of the slab with the half-round holes. This slab they set in place so the slot faced outward. The only unknown factor is at what height was this slab originally. This is a minor factor in the overall

Figure 13 – Undated pre-restoration photo taken from the east side looking westerly showing the foundation of the Tall Wall (indicated by arrows at bottom), the narrow slot into the small room in East-West Chamber (“A”), and Mensal Stone chamber (“B”). (Photo courtesy of the NEARA Archives.)

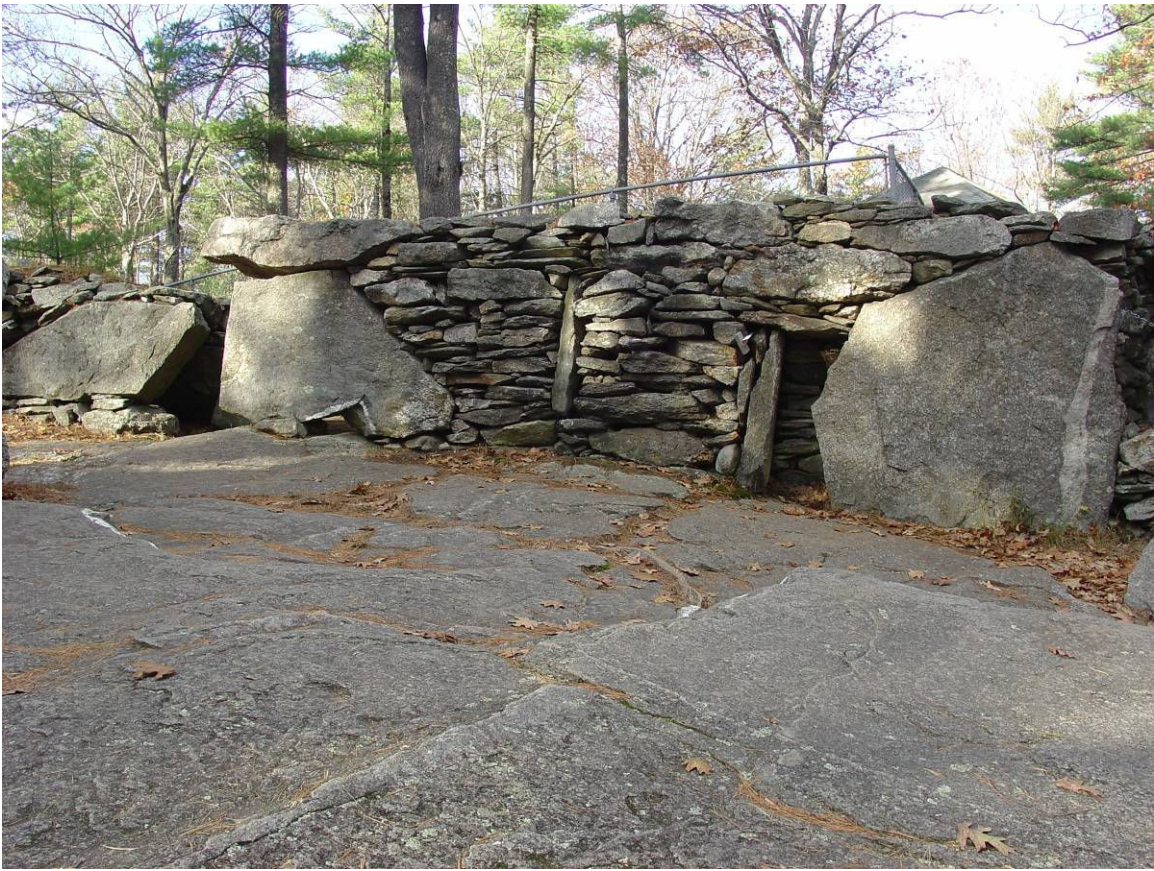
Figure 14 – East-West Chamber as it looks today. (Photograph by James Gage)

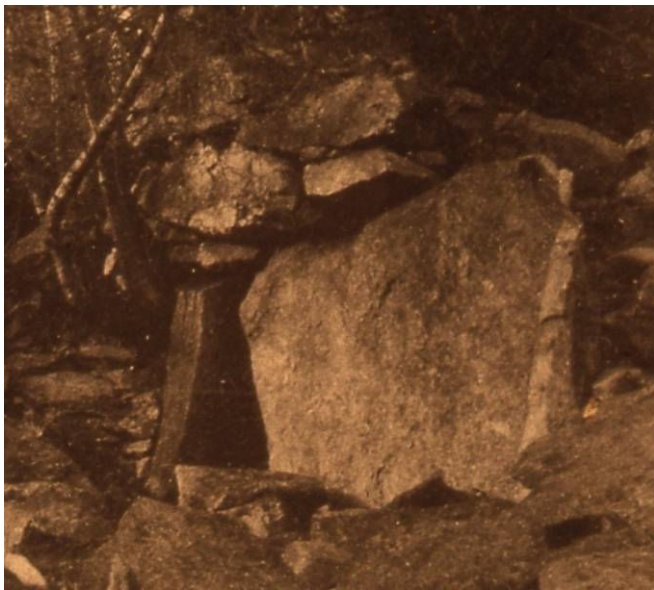
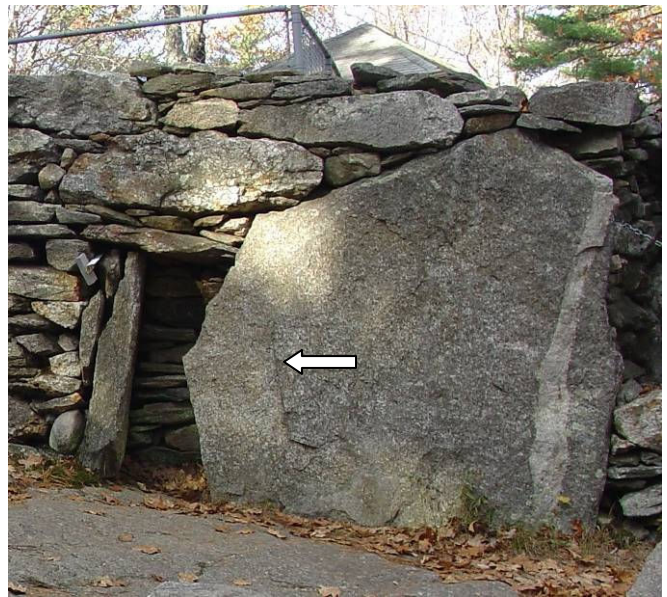
Figure 15 - Comparison of pre-restoration photo of eastern most stone slab of East-West Chamber to a current photo. Although somewhat similar both stones have different shapes. The original slab was replaced by current slab sometime between 1946 and 1958. Arrow indicates vertical ridge in stone – see next figure.

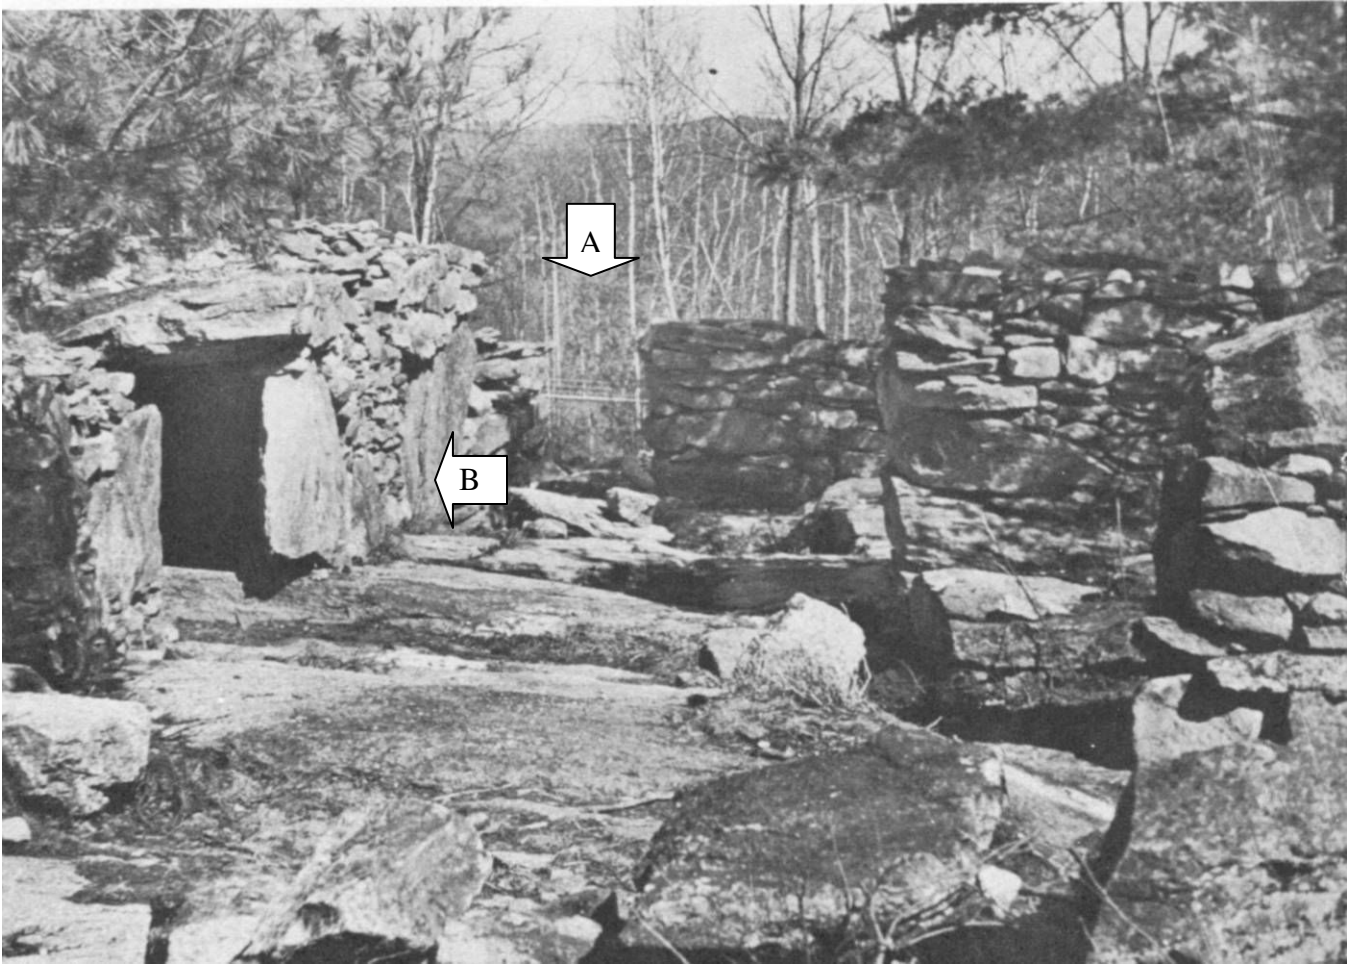
Today the outer area attached to the Oracle Chamber's alcove is walled-in. The wall was added/constructed post 1983 after the alcove was restored. A photograph in the 1958 publication *The North Salem Mystery* shows a view looking east from the V Hut down along the length of the East-West Chamber on the left side, and the north ends of the Mensal Stone Chamber and Tall Wall Chamber on the right side through to the chain link fence. In the area of the Oracle Chamber's alcove entrance there is no stone wall.¹⁸

Figure 16 – Undated post-restoration photo. (Photographer Malcolm Pearson? From Holden 1958)
(A) The wall to the right of the entrance of Oracle Chamber was added sometime after 1858 when this photo was published, the wall is not in this photo.
(B) The shadow indicates a vertical ridge on this stone slab, the same ridge on the current stone. (see figure 15)

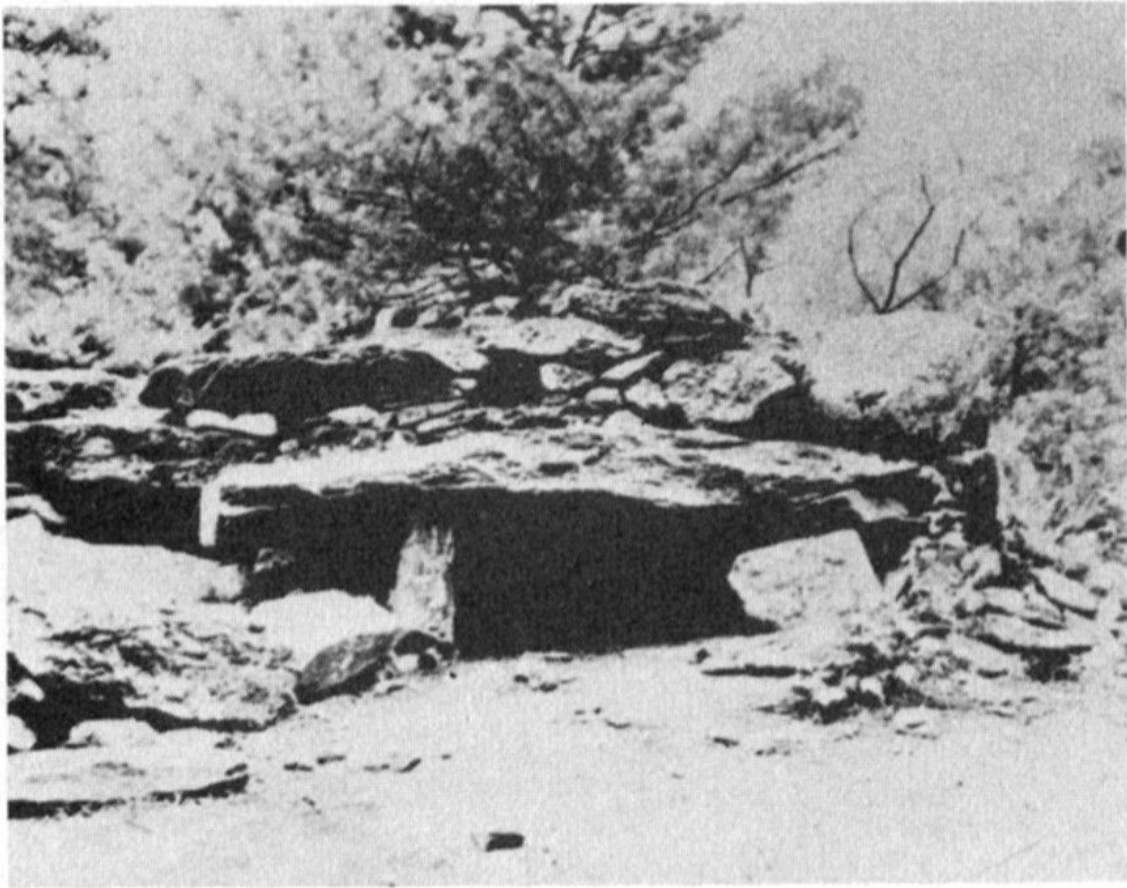
Vescelius via Whitney said the structure's walls "were built up". Structure III includes two low walls of which one contains a large niche, enclosing an area behind structure IIIA (Mensal Stone Chamber) and an adjoining chamber IIIB (Unnamed Chamber). A before restoration photograph of structure IIIA shows the lower two thirds containing the chamber was intact and in its original state. (fig.20) Only, the upper one third was restored. (fig.21) Goodwin's crew had the advantage of studying the thick wall's style of construction from the lower two thirds. In doing so, they were able to reconstruct the upper one third to match the lower section. This could only be done due to the fact the stones within the three feet radius were similar to the ones in the lower section.

Figure 20 – Undated pre-restoration photo of the Mensal Stone Chamber showing only the upper one third of the structure was restored. (Photographer unknown from Vesce Luis 1983)

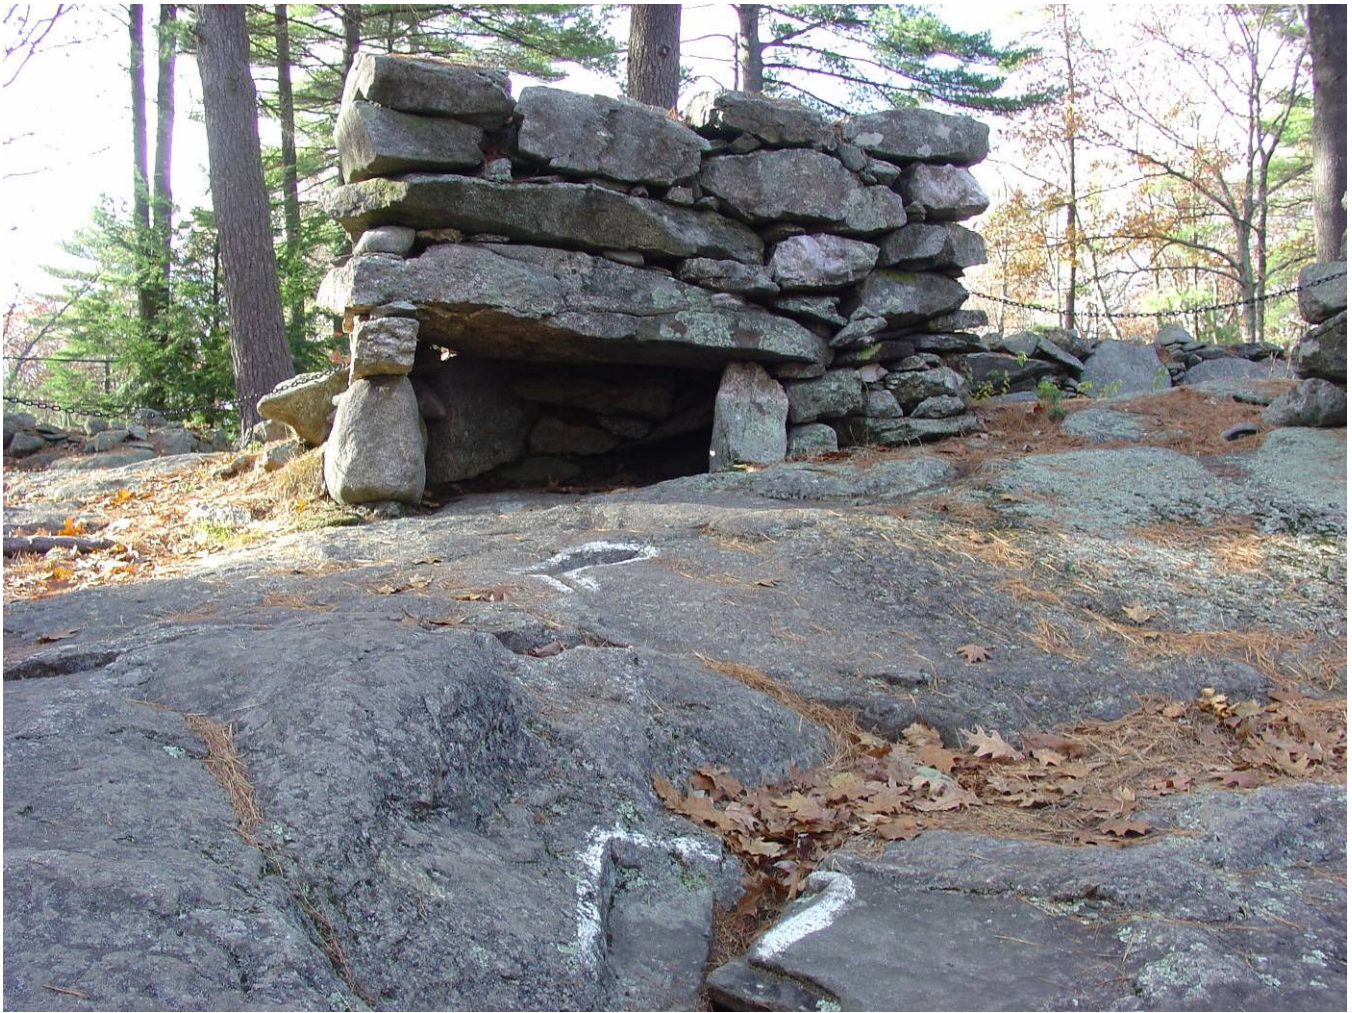
The fact is the stones in the tall wall above the Unnamed Chamber were taken down to the chamber's roof slab by the men removing stone from the site. This was probably done for two reasons: (1) the tall wall above the chamber likely interfered with the stones being moved from the plaza up to the upper area to be loaded onto wagons. That is a narrow area to move the slabs through. (2) The roof slab was probably slated to be removed from the site. Vescelius thought the chamber was in its original state and supposed it resembled the V Hut a chamber without a wall above it. He erred when he did not take into

Figure 22 – Current photo of Unnamed Chamber. The section above the roof slab was restored.
(Photograph by James Gage)

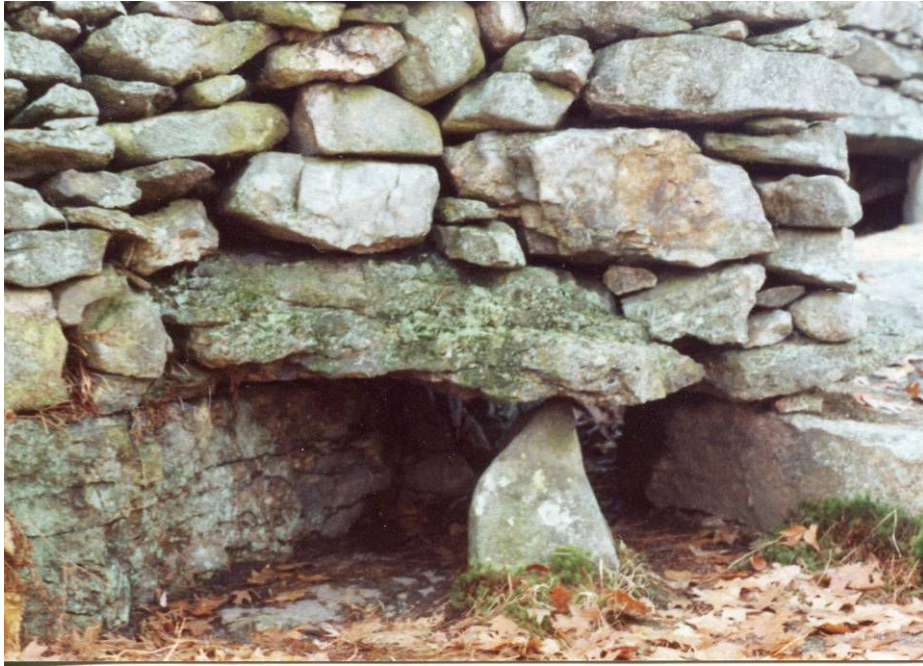
What was not disturbed was the lower section with the covered drain. (fig.25) Its similarity to the covered drain exit in the Ramp indicates it is in its original state and has never been altered.

Figure 25 – Close-up of the drain exit under the Half-Circle Enclosure.
(Photograph by Mary Gage)

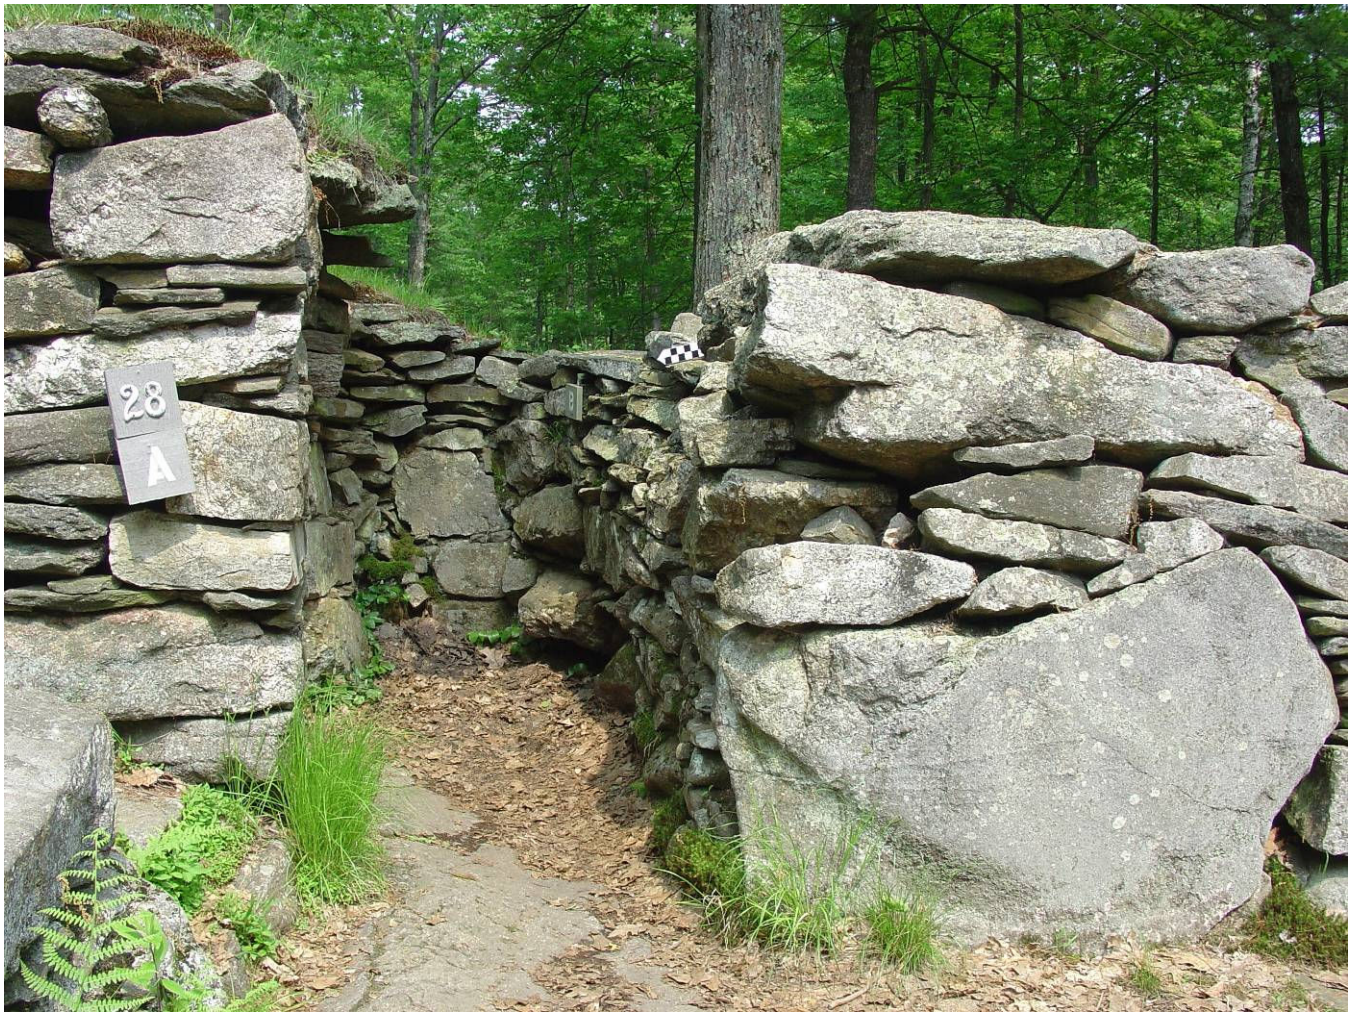
Figure 28 – Current photo of the entrance (alcove) of the Oracle Chamber. The roof stones are missing.
(Photograph by James Gage)
